## Meter Engineering and Automation Metering Standards Bulletin

Issued By:	Number:	Date Issued:
Meter Engineering	2015-002	04/23/2015

## **OPENWAY METERS FAILURE UNDER INVESTIGATION**

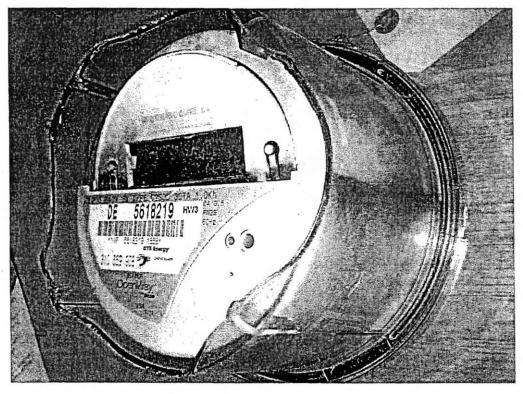
Meter Engineering has identified a handful of OpenWay Centron Form 2S 240V meters that have failed due to overvoltage. As you can see in the picture below the front of the polycarbonate meter cover has been blown off. The investigation is ongoing and your assistance is required.

Please contact Florin Moldovan of Meter Engineering at (313) 389-7617 to report such sites and assist with the field investigation.
