Issued By:
Meter EngineeringNumber:
2015-002Date Issued:
04/23/2015**OPENWAY METERS FAILURE UNDER INVESTIGATION****Purpose of Communication**

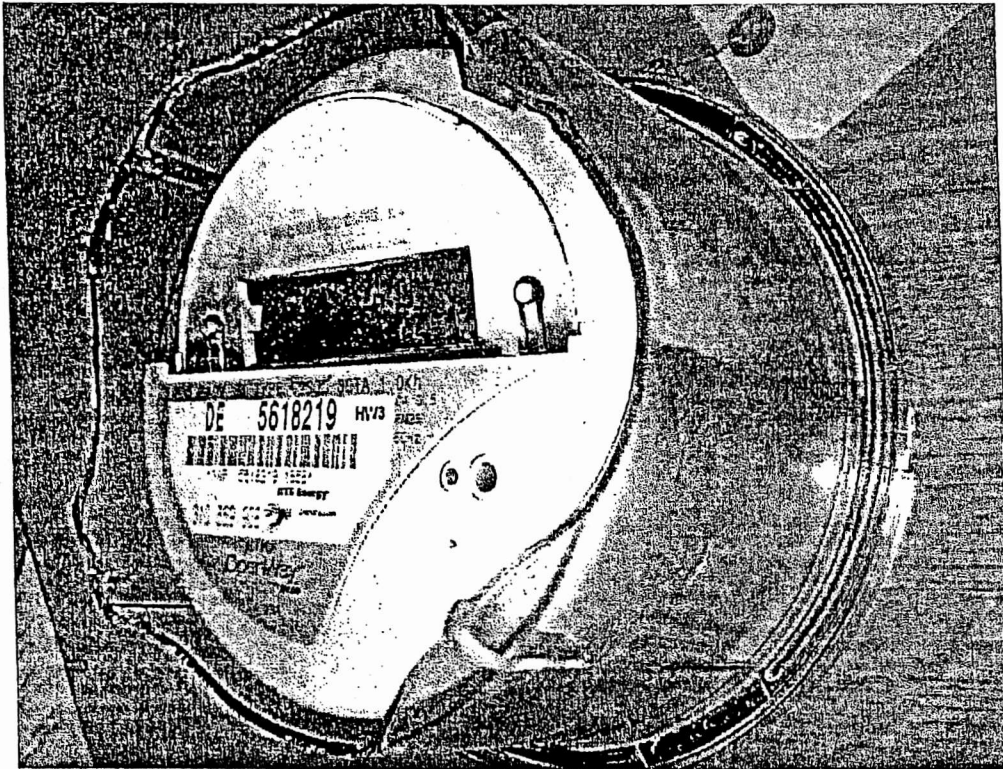
Meter Engineering has identified a handful of OpenWay Centron Form 2S 240V meters that have failed due to overvoltage. As you can see in the picture below the front of the polycarbonate meter cover has been blown off. The investigation is ongoing and your assistance is required.

**ACTION Required by All Field Personnel:**

Please contact Florin Moldovan of Meter Engineering at (313) 389-7617 to report such sites and assist with the field investigation.
