**RE: British Columbia Utilities Commission (BCUC or Commission)
British Columbia Hydro and Power Authority (BC Hydro)
Meter / Meter Base Fire or High Temperature Safety Incident Semi-annual
Compliance Report No. 3 – July 1, 2017 to December 31, 2017 (Report)**

Power Quality Report

File #2017.10.0596

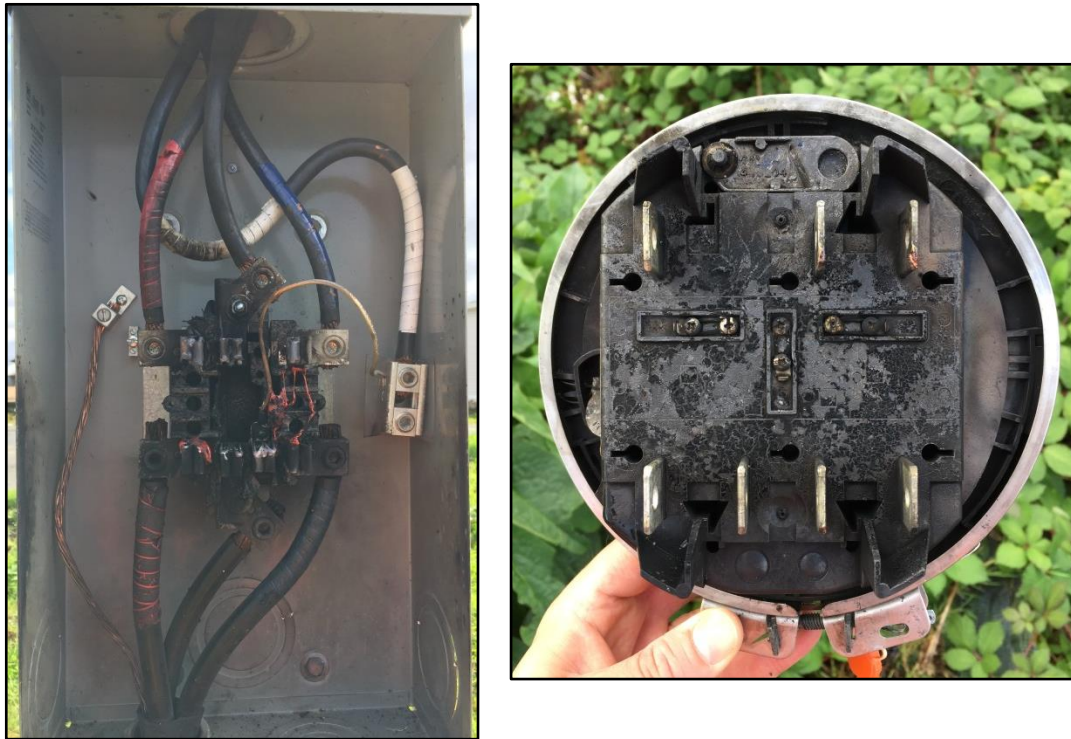
Figure 1 - Meter base and revenue meter damage

On Saturday October 7, 2017 the line crew received a trouble call in Ahousat on circuit [REDACTED]. The complaint was that the meter base [REDACTED] was arcing and sparking. The meter base is located outside on a private pole [REDACTED]. Once on site, the crew discovered that the revenue meter had blown out of the meter base and landed approximately 4.5 metres away. The meter base sustained substantial damage, melting both the socket and the back of the meter as shown below.

Further damage was observed at the conduit between the meter base and the weatherhead as the brackets and conduit appeared to be separated from the bottom half of the pole.

The crew also noticed that the B-phase transformer cutout was open. No birds or animals were found at the base of the pole.

Ferroresonance often causes symptoms of overheating on a transformer, or in this case the meter cabinet, which is consistent with what was found. The overvoltage associated with the resonance can also take several seconds to minutes to increase to magnitudes that cause damage. This would explain why the meter took so long to fault. Finally, none of the overcurrent protection on the customer's secondary operated during this event, nor is any damage evident to the breaker panels or transformers. Therefore, ferroresonance is the most likely explanation to this incident.

Since the issue is likely caused by customer equipment it is their responsibility to address concerns with their electrical system. It is recommended that the customer engage their electrical consultants to determine an appropriate course of action for mitigation of ferroresonance.

1. Install permanent resistive load banks on each transformer secondary of 5% - 10% of the nameplate capacity.
2. Install loss-of-phase protection to ensure that if one phase of the service is lost, all three phases will trip.

1. Installing a ferroresonance dampening device on the transformer secondary could be considered.

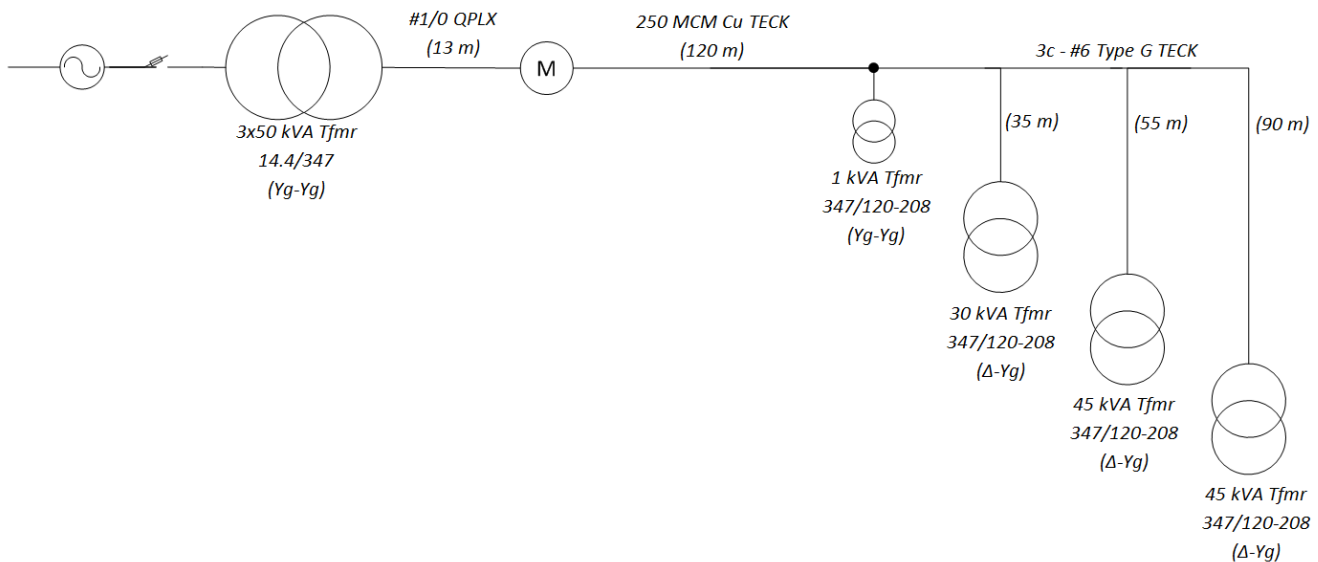
Figure 2 - Secondary network diagram

The customer is served via dedicated 3x50 kVA transformer bank with approximately 13 metres of #1/0 Quadruplex to the meter base. The transformer configuration is grounded-wye – grounded-wye. The customer loading is minimal; with only a 1 kVA transformer serving approximately 10 LED dock lights, and three transformers (45 kVA, 45 kVA, and 30 kVA), serving receptacles for boat users. The duty on the receptacles is near zero as they are only used on an ad hoc basis.

Since the transformers on the dock are connected delta-wye, only three conductor #6 TECK cable is used to supply them. A separate G-Type cable with a ground conductor runs in parallel out the dock fingers to provide a ground for the transformer secondary. This cable is grounded by three electrodes adjacent to the meter pole.

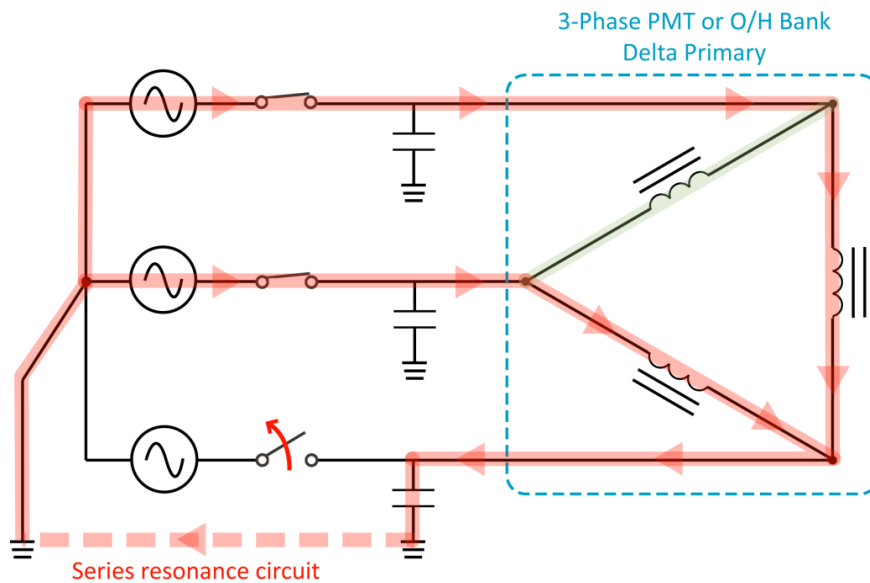
Figure 3 - Ferroresonant circuit in a delta connected primary transformer

Figure 3 shows the series resonant circuit of a delta connected primary transformer when one phase is open.

Another factor that must be considered is the available capacitance in the circuit to resonate with the transformer. This is indicated in Figure 3 by the cable capacitance to ground and internal transformer capacitance that are in series with the transformer inductance. .

At the [REDACTED] there is between approximately 170 m and 225 m of cable between the BC Hydro service transformer and the customer's delta connected dock transformers. Note that for a smaller transformer such as the customer's dock transformers, it takes far less capacitance to cause resonance. This is due to the fact that the inductance in the transformer winding is much smaller in these transformers and when the transformer saturates (as in ferroresonance); the leakage inductance is even smaller than that.
